# EXIDE FACILITY CLOSURE, PHASE I

# Closure, Phase I - Overview

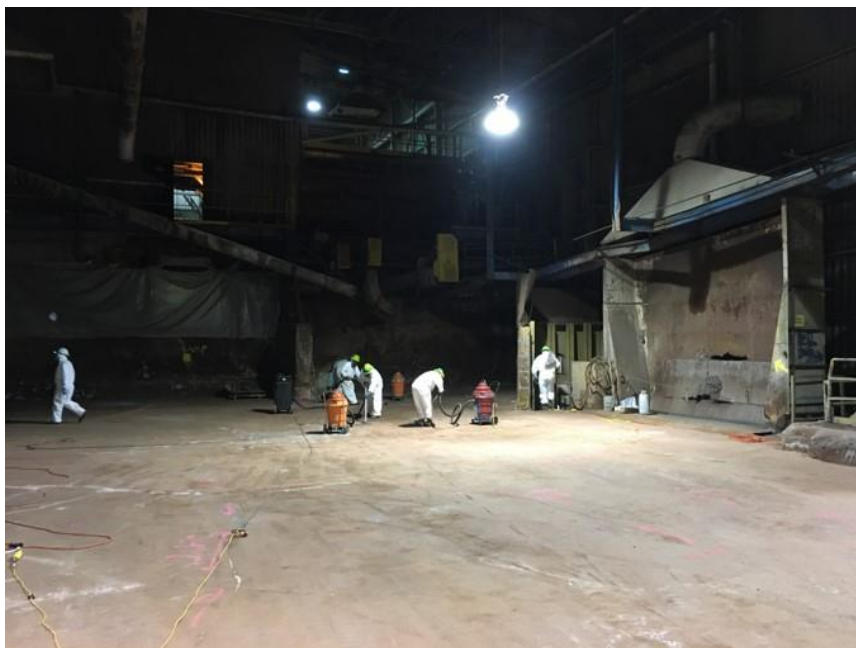
Dry decontamination/HEPA vacuum

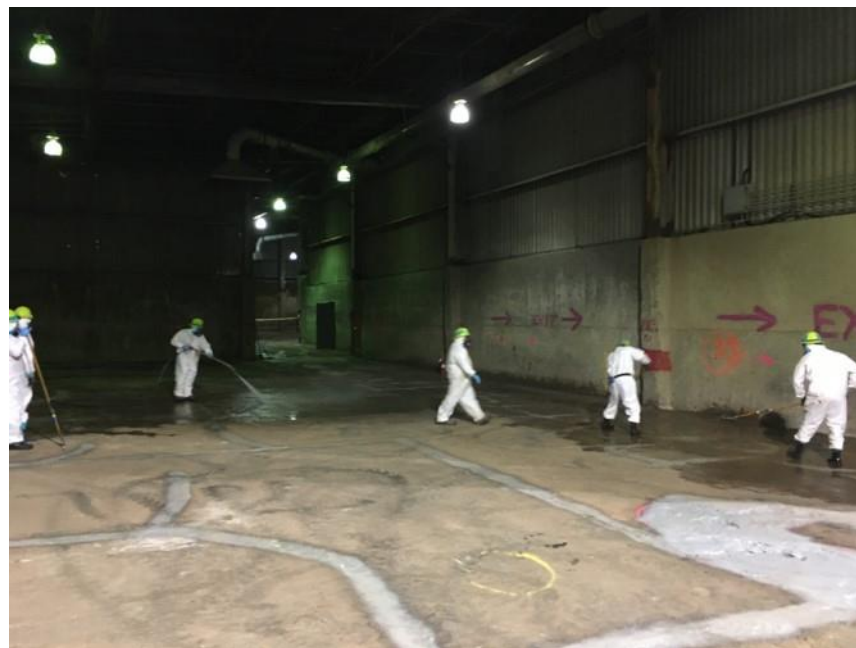
Wet decontamination/pressure wash

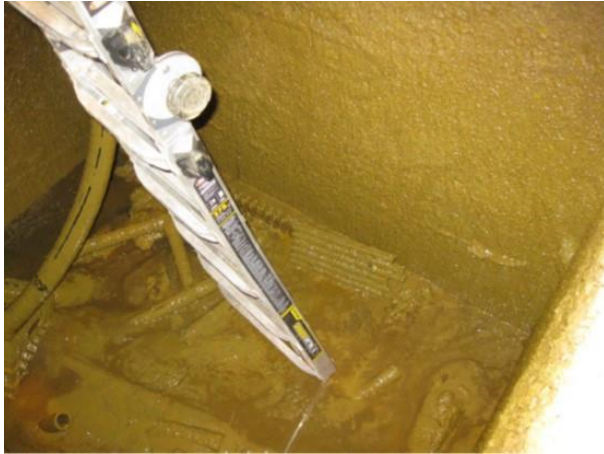
Before

## Sump Decontamination – Before, During, After

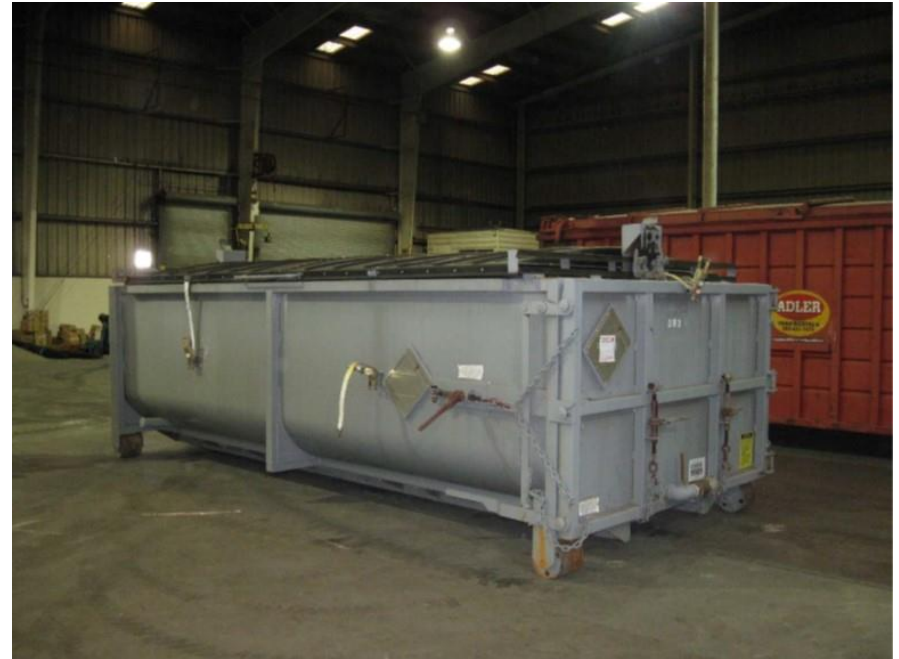
- Waste Bin
  - Covered
  - Decontaminated before hauling off-site

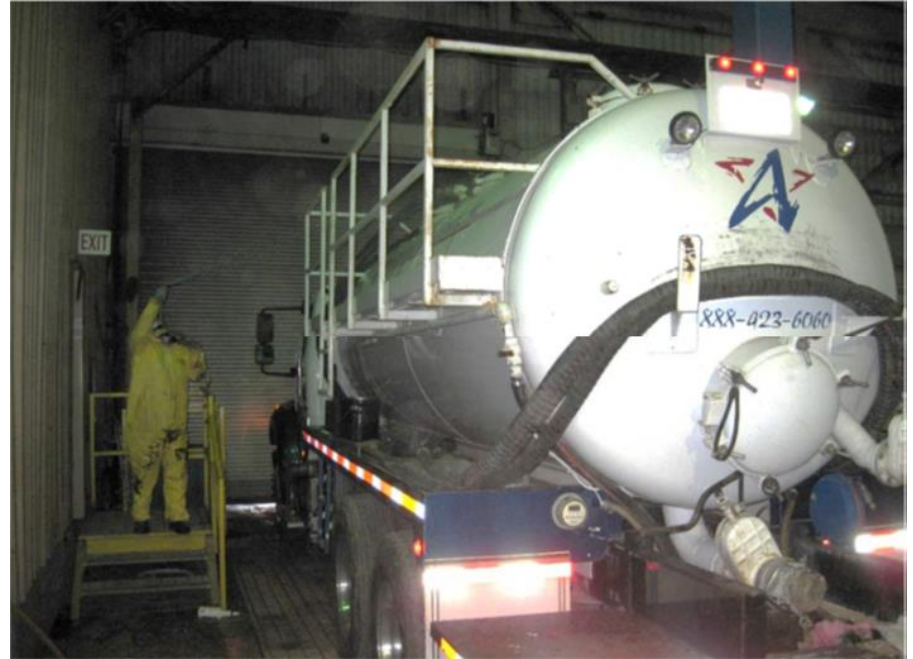
- Vacuum-Truck/Vehicle Decontamination
  - Triple rinse decontamination
  - Performed before leaving containment building

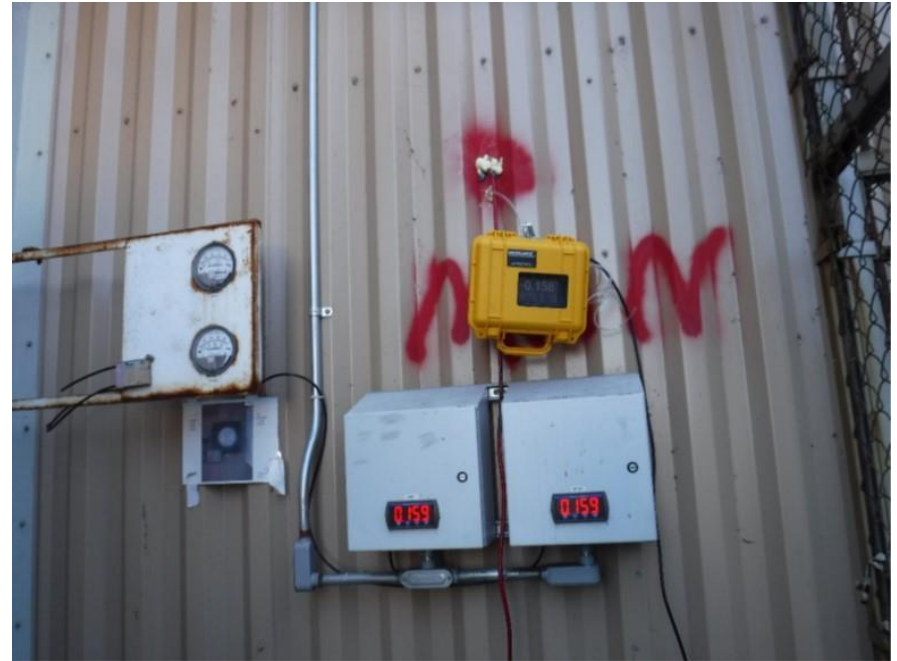
- Enclosure Building Anemometer
- Continuously recorded
- Requirement of Title V Permit

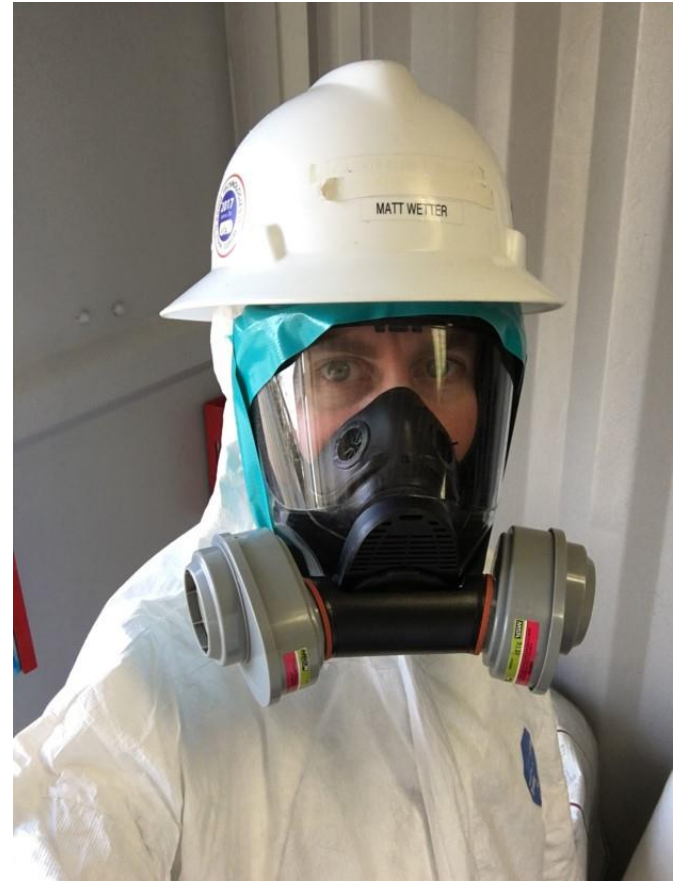
- Standard Personal Protective Equipment (PPE)
  - Full face respirator – protection factor 50
  - Tyvek coveralls
  - Nitrile gloves
  - Hardhat, steel toe boots
  - Tyvek or rubber over boots
  - Post-work decontamination

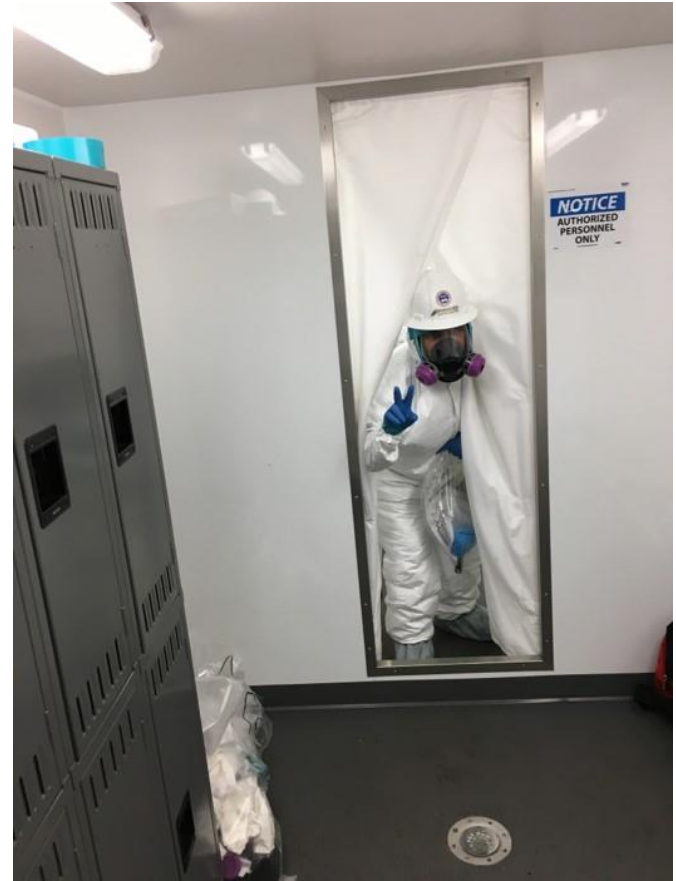
- Three Stage Decontamination Procedure
  - Boot wash
  - Wipe down Tyvek, gloves, equipment
  - Remove coveralls
  - Wipe down skin
  - Remove respirator
  - Optional shower based on work task
